## NuGlaze Rain Erosion Test Boeing Report

## Work Request 200803109-S00 – “Paint Sealant Evaluation in Support of CITAP 2214; Assessment of “NuGlaze with PFS”, " " materials”.

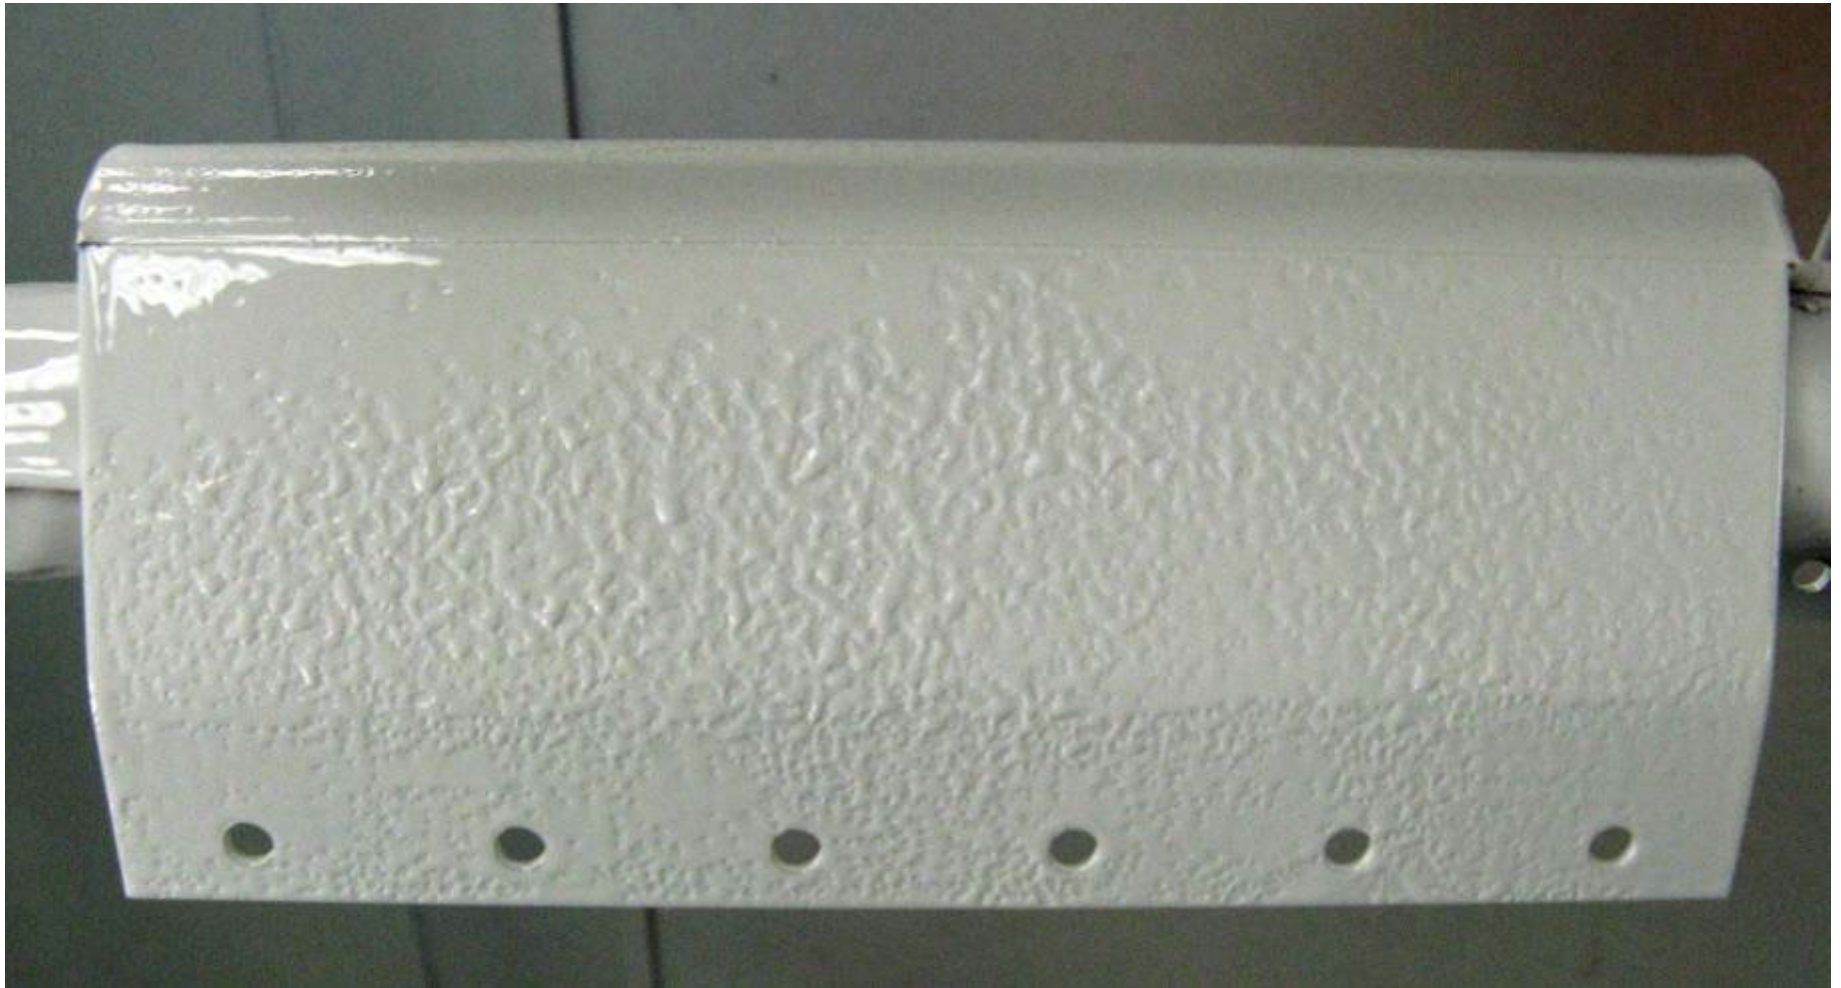
Picture 1.5-1; Typical Example of Secondary Topcoat De-wetting When Applied over Topcoat with Paint Sealant Applied

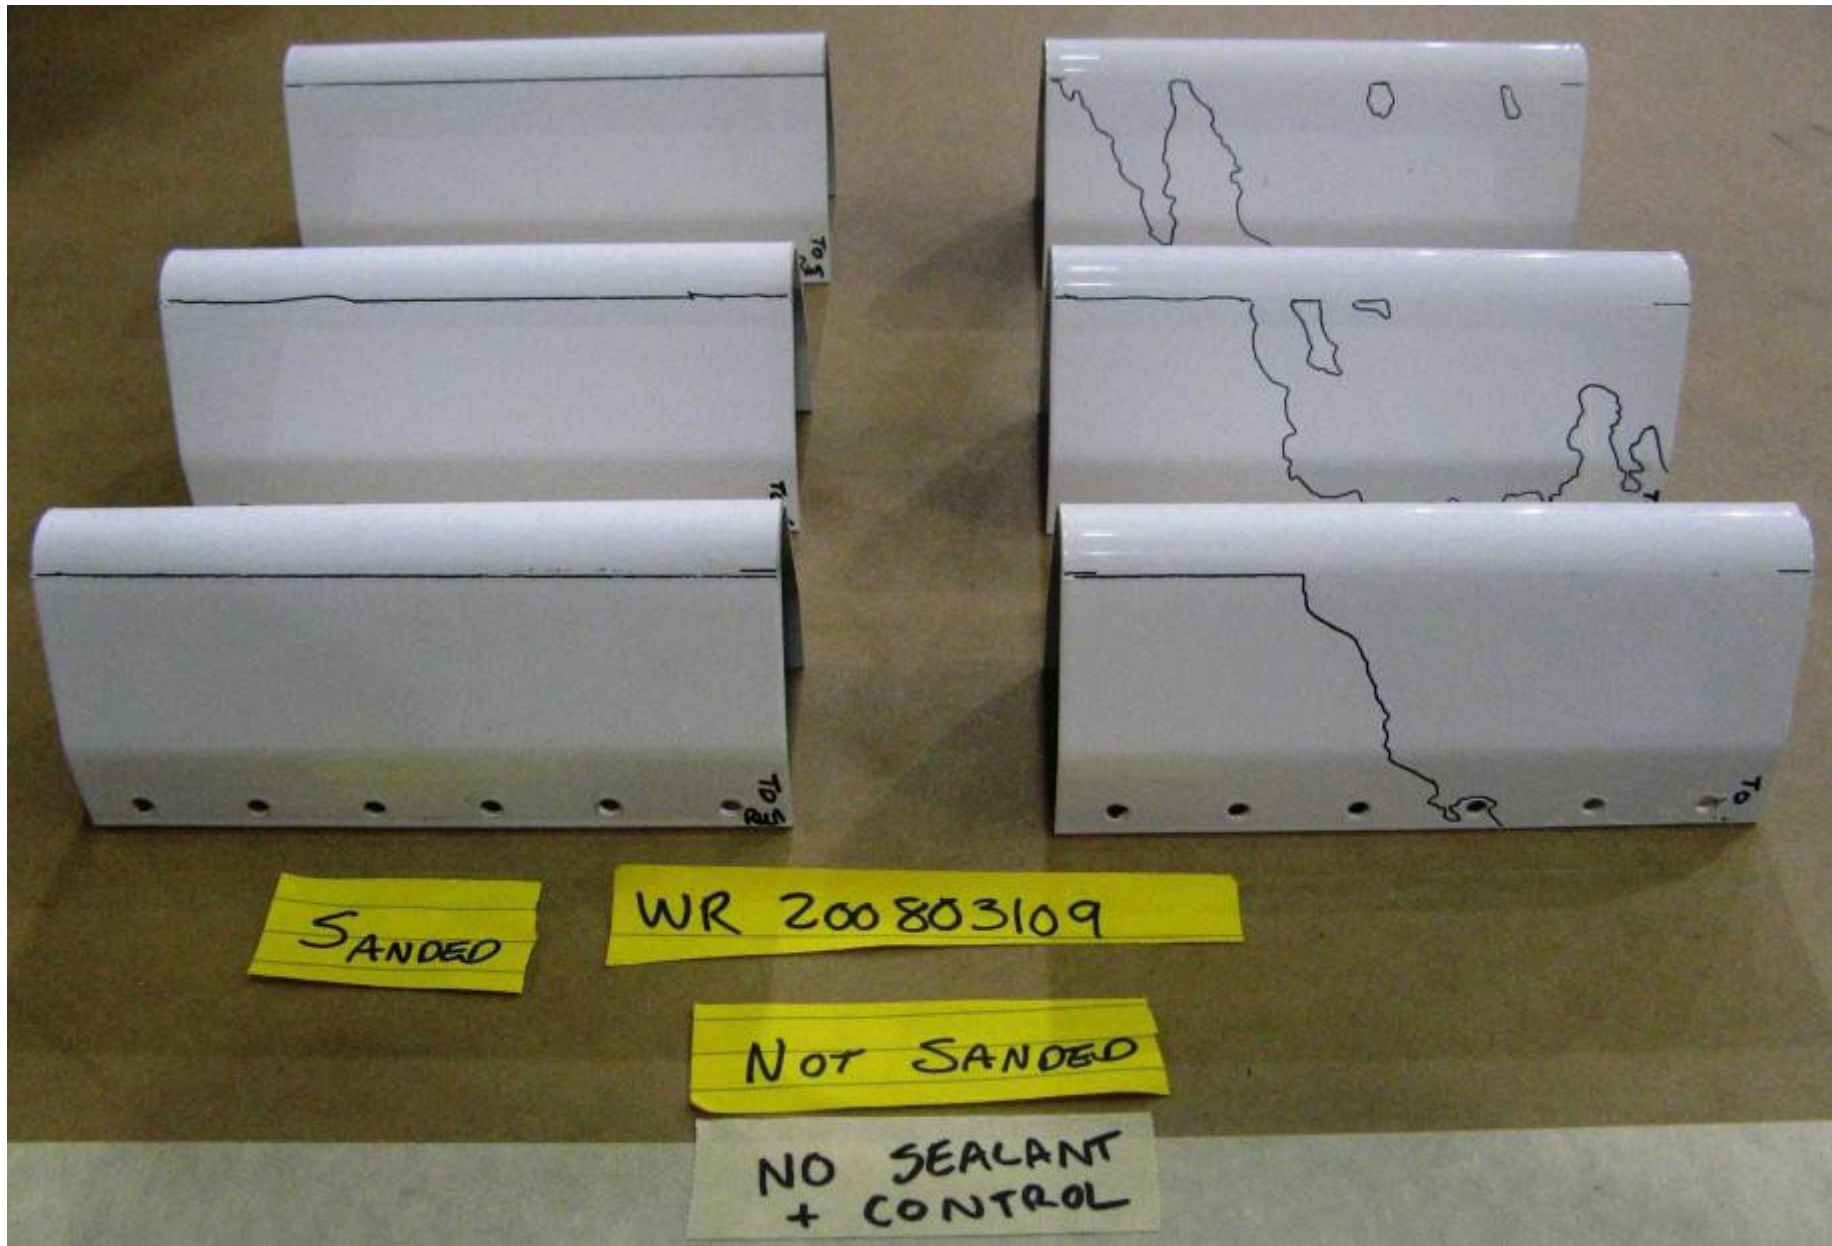
Picture 1.5-4; Post Rain Erosion, Overcoat Adhesion, No Paint Sealant, Control Foils

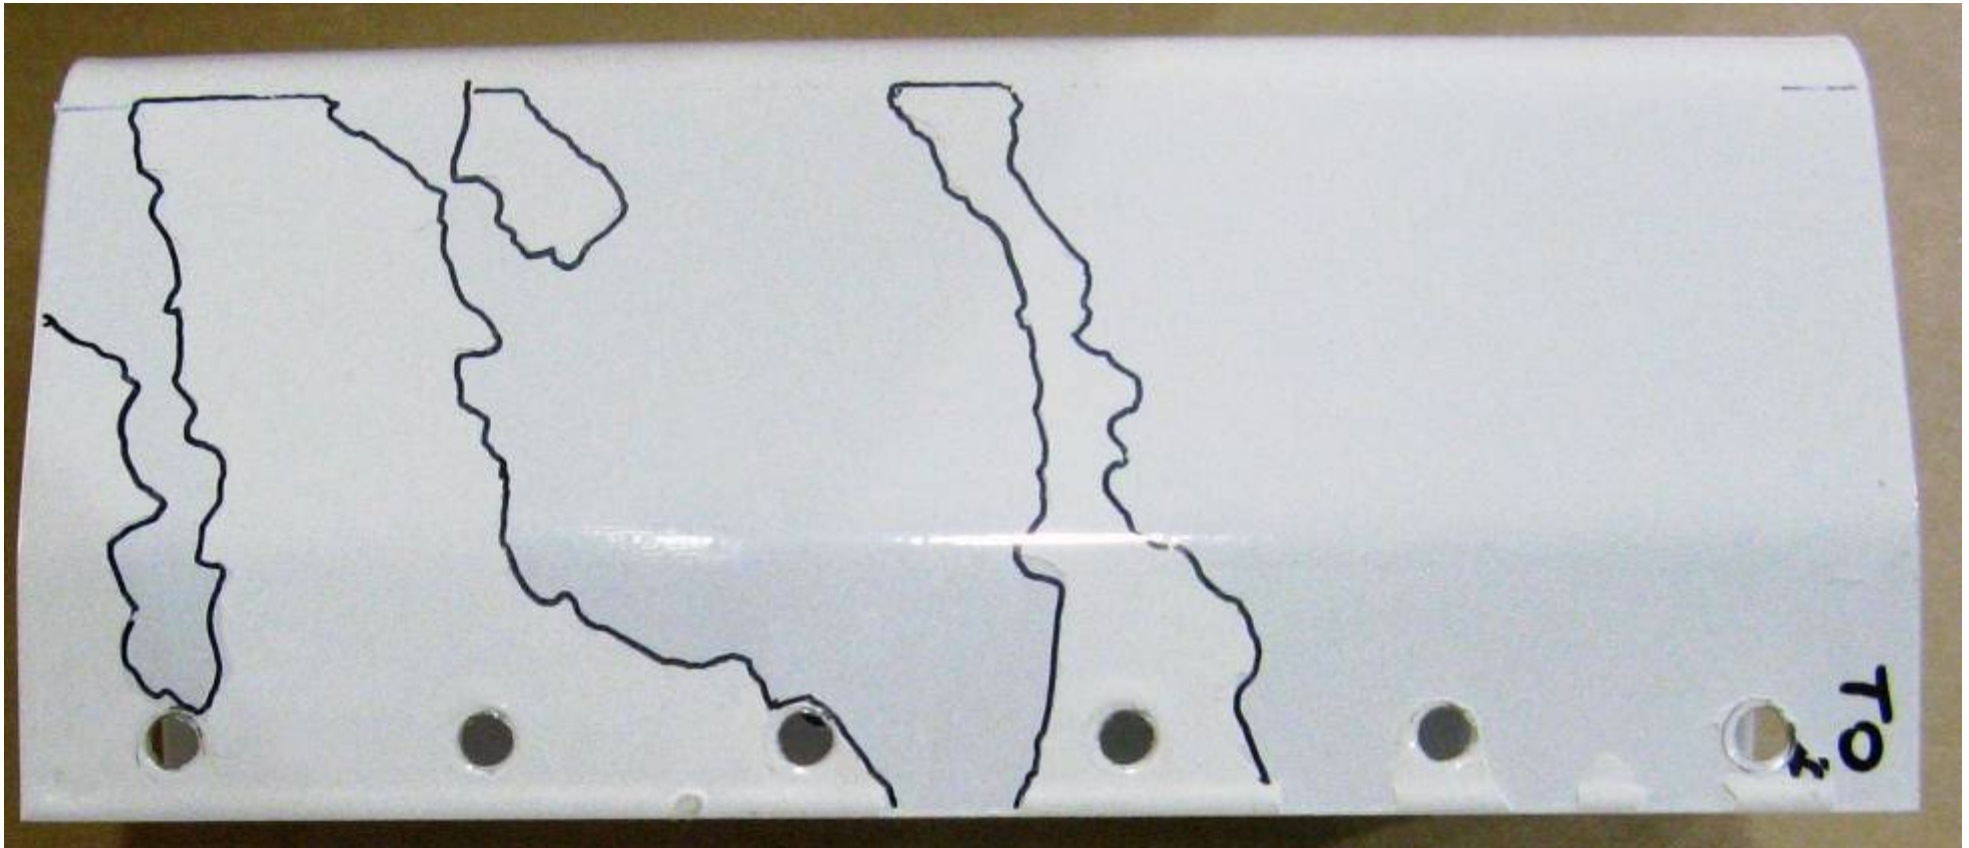
Picture 1.5-9; Close-Up of Completed Rain Erosion Foil. Black Lines Highlight Remaining Secondary Topcoat

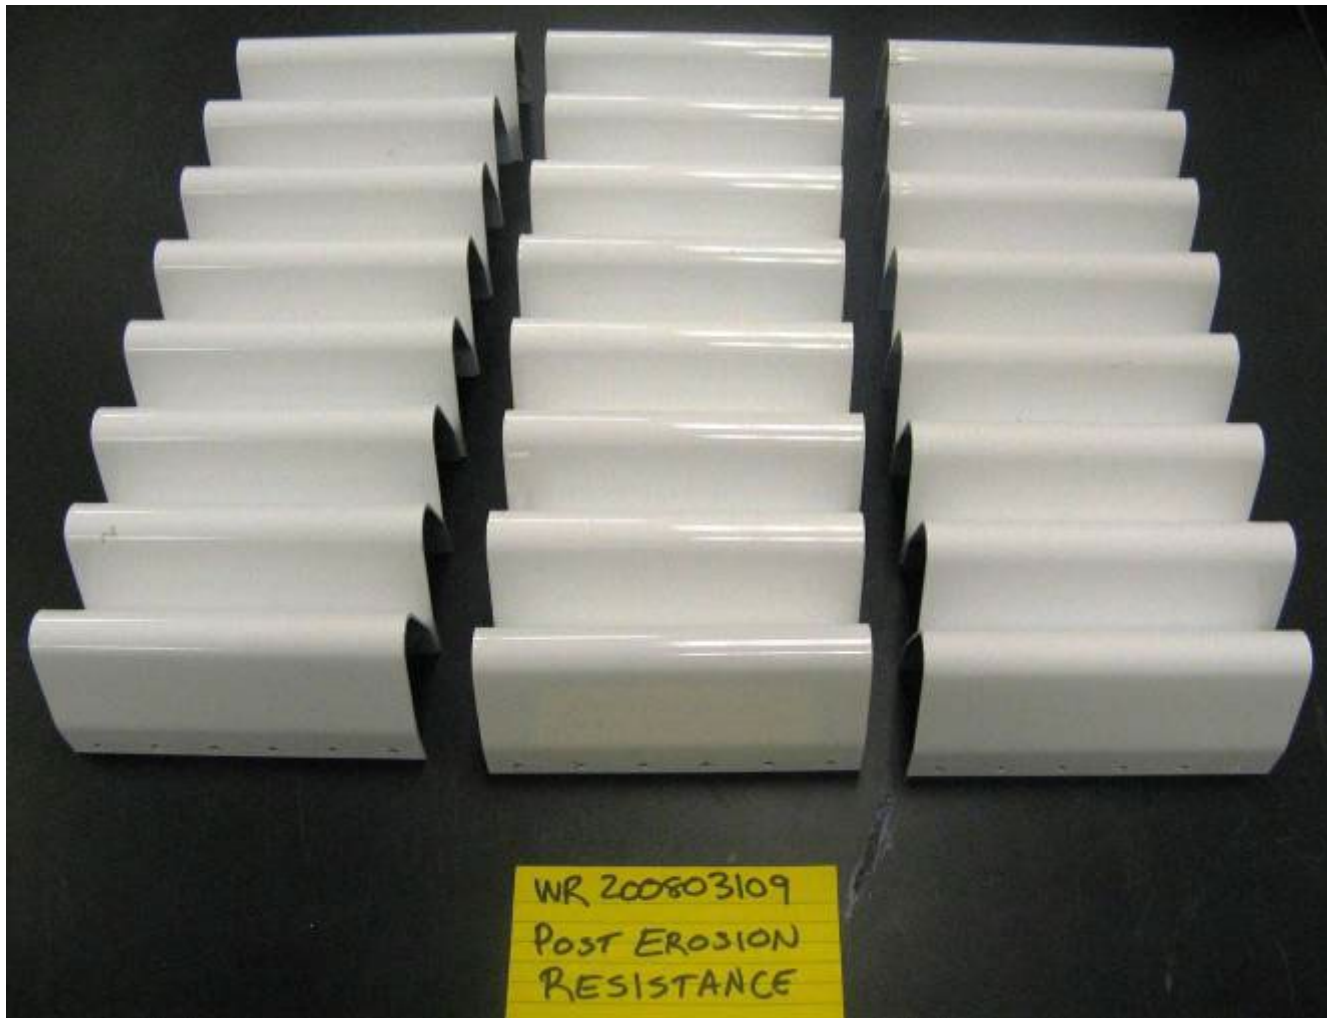
Picture 2.3-2; All Painted and Sealant-Treated Rain Erosion Foils Following Rain Erosion

2. All of the paint sealants withstood 30 minutes of simulated rain erosion per BSS7393 type II (385 miler per hour average) and remained present on the painted rain erosion foil.
