## SKYDE CLEAR

**Product Name:** Skyde Clear

### **Application defect & Identification.**

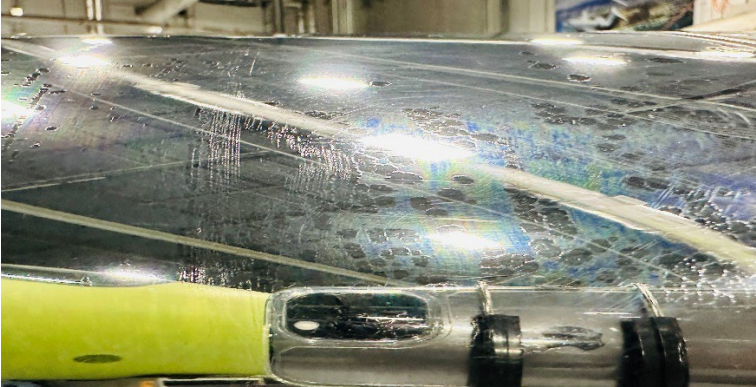
### Blotching / Pullaway

This is the result of some of the previous coating or protection still present before application. Re-polish with G6, S etc and repeat the application.

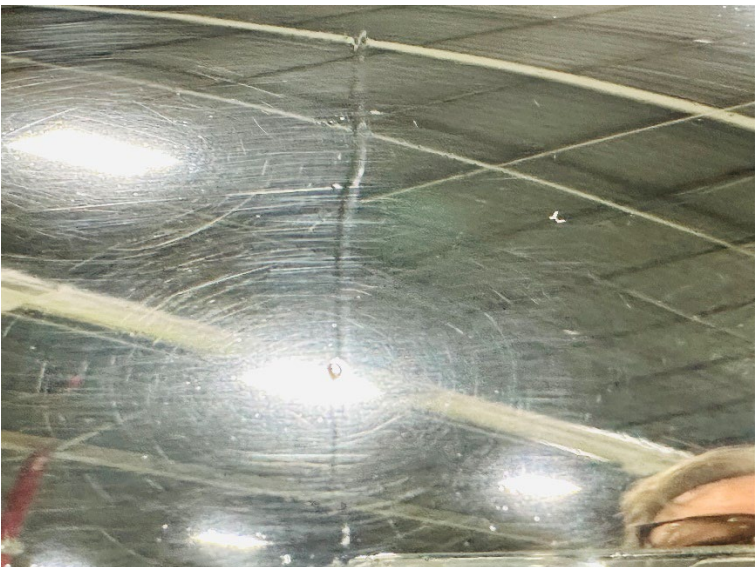
### Build Up Line

When applying, ensure that the junction between each pass meets without excessive overlapping.
